The Tetra Tech Superfund Technical Assessment and Response Team (START) is pleased to submit the draft Emergency Response Letter Report summarizing emergency response activities conducted at the Wingate Farms Pesticide Response (TDD No. TTEMI-05-001-0196) located in Leesburg, Georgia.

**Subject: Draft Emergency Response Letter Report  
Wingate Farms Pesticide Site  
Leesburg, Lee County, Georgia  
EPA Contract No. EP-W-05-054  
TDD No. TTEMI-05-001-0196**

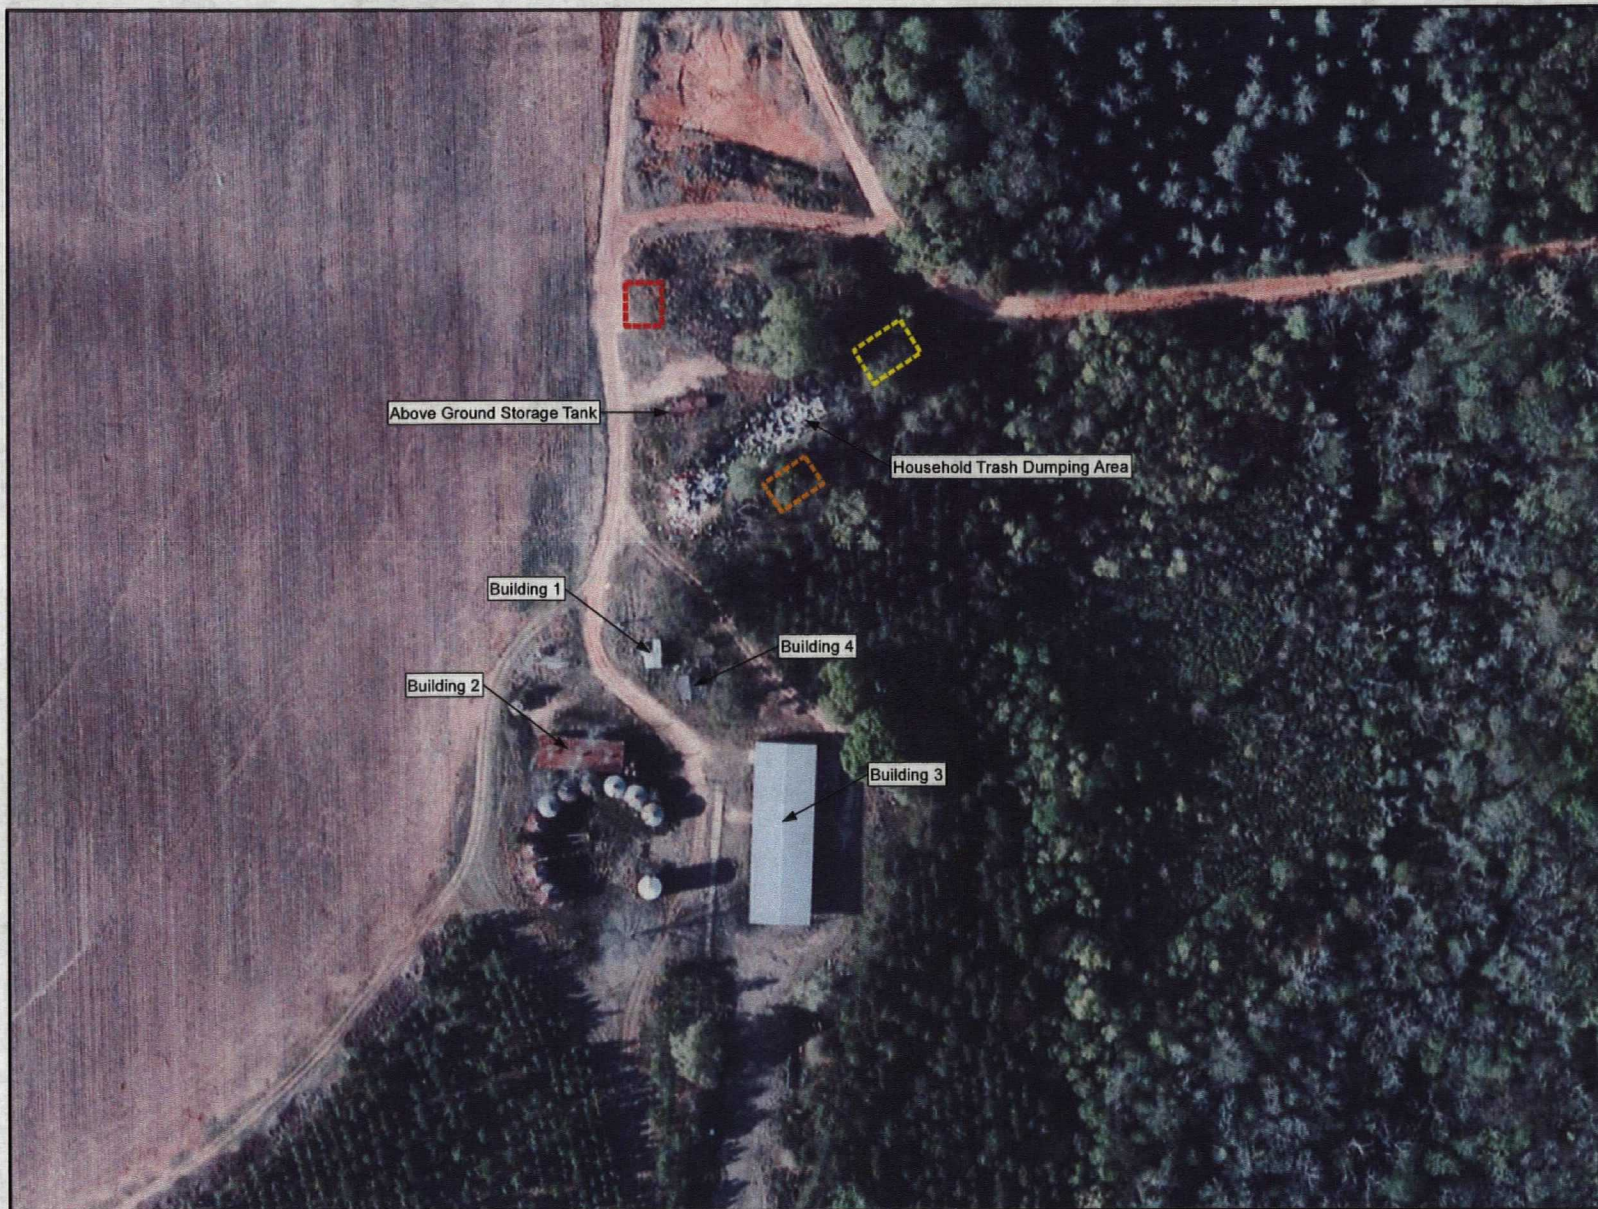
**FIGURE 2**

- Legend**
- Soil test boring location
  - Location of discarded pesticide containers
  - Canvas peanut bag dumping area

**Site Layout**

Tetra Tech START arrived on site on the afternoon of May 31, 2013 and met EPA On-Scene Coordinator (OSC) Jose Negron, Lee County Board of Commissioners Code Enforcement Officers Jim Wright and Ben Roberts, and Jay Smith of the Georgia Department of Agriculture. OSC Negron provided details of the property owner's actions to date and led Tetra Tech START on a tour of the site. The site consisted of a peanut cart containing empty pesticide and herbicide containers; two ravines one containing household trash and one containing canvas peanut bags; two above ground storage tanks (AST) estimated to contain approximately 500 gallons each of petroleum products reportedly used for farm equipment; one reportedly empty AST with an estimated capacity of 10,000 gallons; and four buildings as described below (see Figure 2 in Enclosure 1):

- Building 1 – The northern-most building utilized as a chemical storage shed. Most of the containers of pesticides and herbicides were observed on pallets located on bare soil in this building.

- Building 2 – Located south-southwest of Building 1. Several drums and a few pesticide and herbicide containers were observed on a concrete floor at this location. Additionally, old farm equipment was stored at this location.

- Building 3 – Located east of Building 2 and the largest of the site buildings. Approximately one-third of the building was fully enclosed and the remaining portion of the building was only covered by a roof canopy. The fully enclosed portion of the building was locked and was not accessed during response activities. Several containers were sparsely located around this building, most of which were either empty or determined to contain rainwater based on appearance and pH testing.

- Building 4 – Located southeast of Building 1 and empty. The structure appeared to be damaged and was not accessed during response activities.

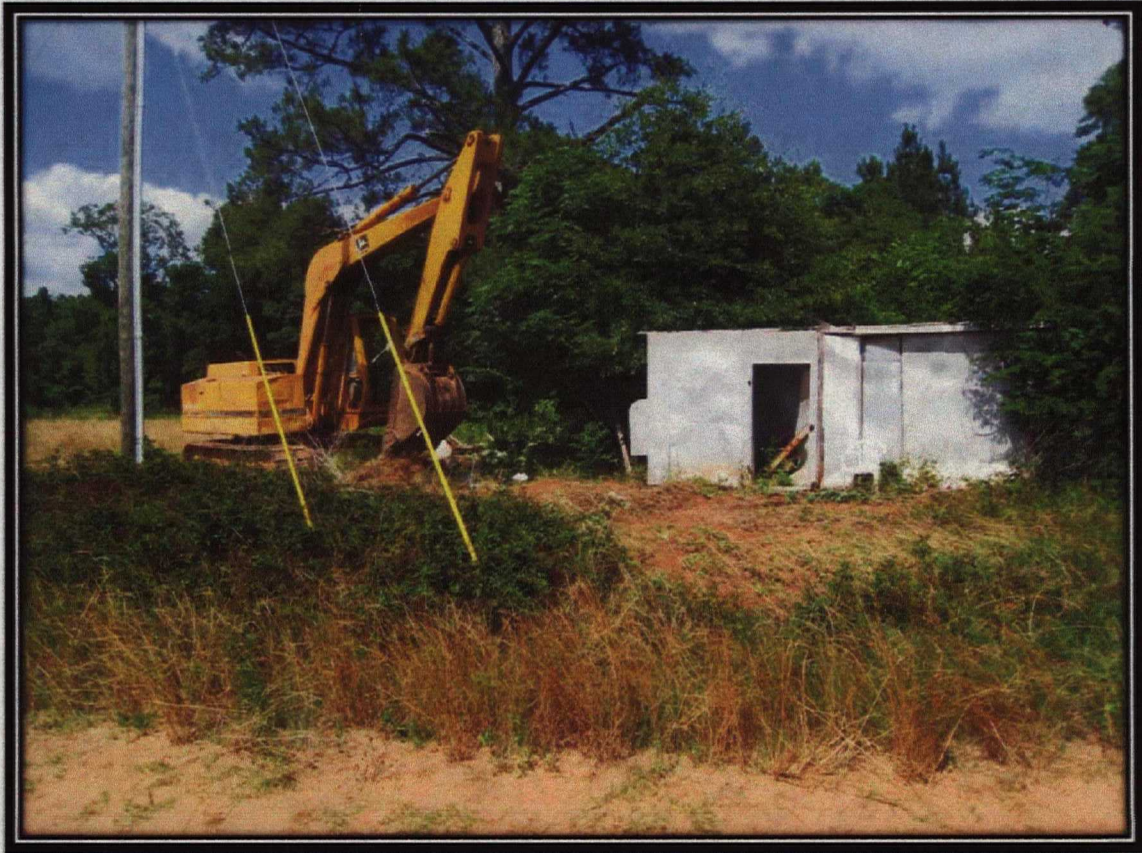
**OFFICIAL PHOTOGRAPH NO. 1**  
**U.S. ENVIRONMENTAL PROTECTION AGENCY**

**Subject:** Building 1 where various containers of pesticides, herbicides, insecticides, and fungicides were located.

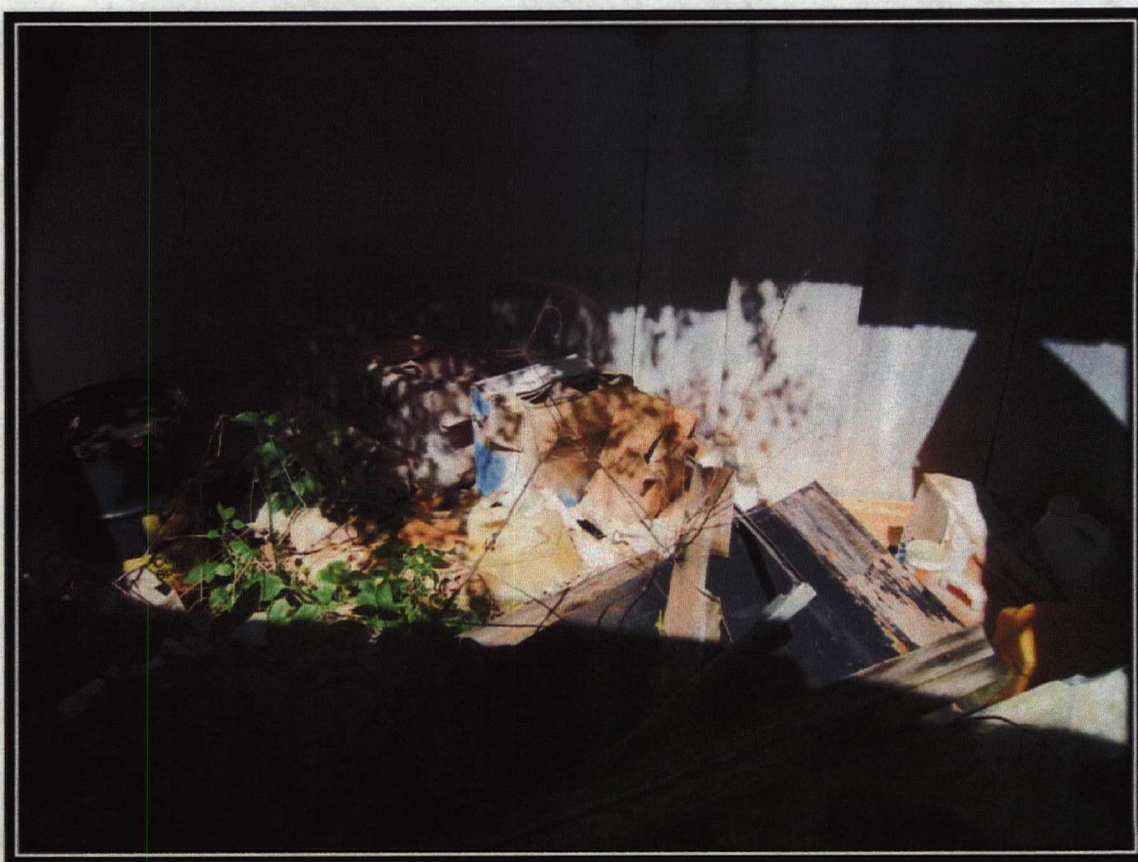
**OFFICIAL PHOTOGRAPH NO. 2**  
**U.S. ENVIRONMENTAL PROTECTION AGENCY**

<b>TDD Number:</b>	TTEMI-05-001-0196	<b>Location:</b>	Wingate Farms Pesticide Site
<b>Orientation:</b>	Northeast	<b>Date:</b>	May 31, 2013
<b>Photographer:</b>	Brian Croft, Tetra Tech	<b>Witness:</b>	Chris Jones, Tetra Tech
<b>Subject:</b>	Various drums, containers, and debris located inside Building 1.

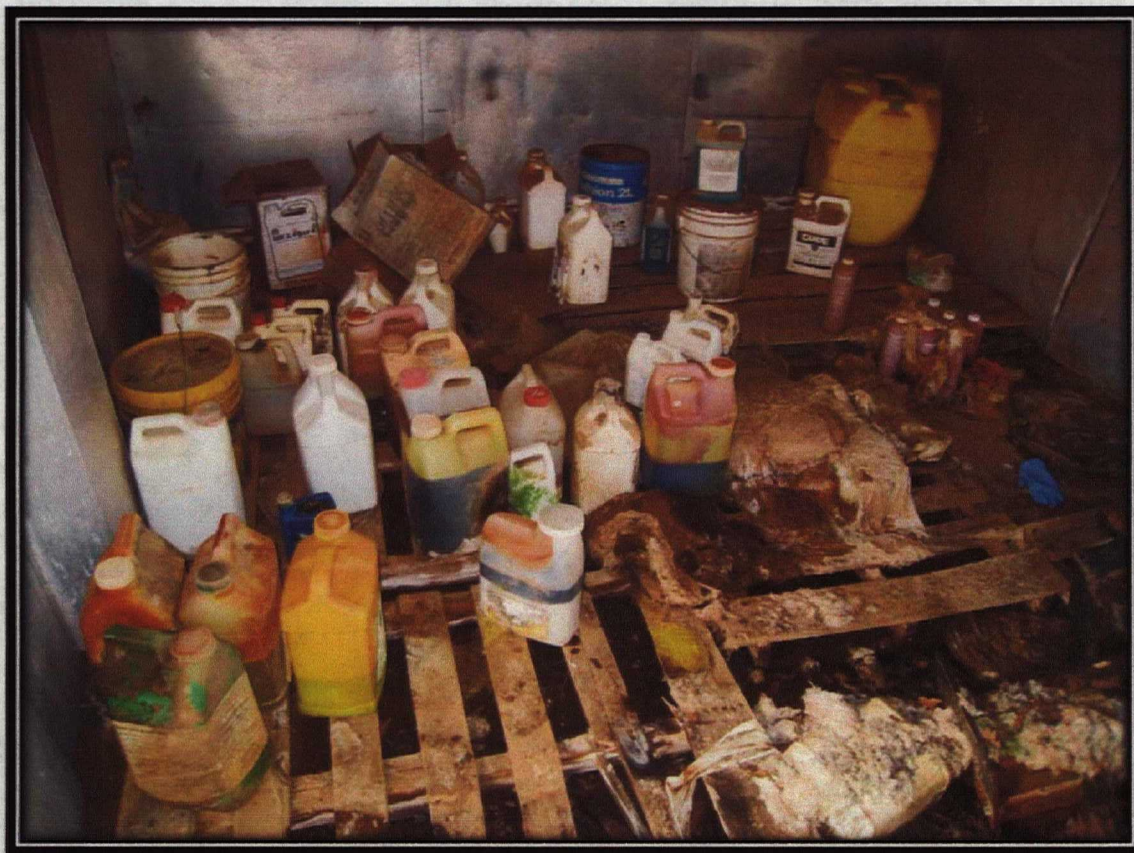
**OFFICIAL PHOTOGRAPH NO. 3**  
**U.S. ENVIRONMENTAL PROTECTION AGENCY**

**Subject:** Various drums and containers placed on pallets over bare soil located inside Building 1.

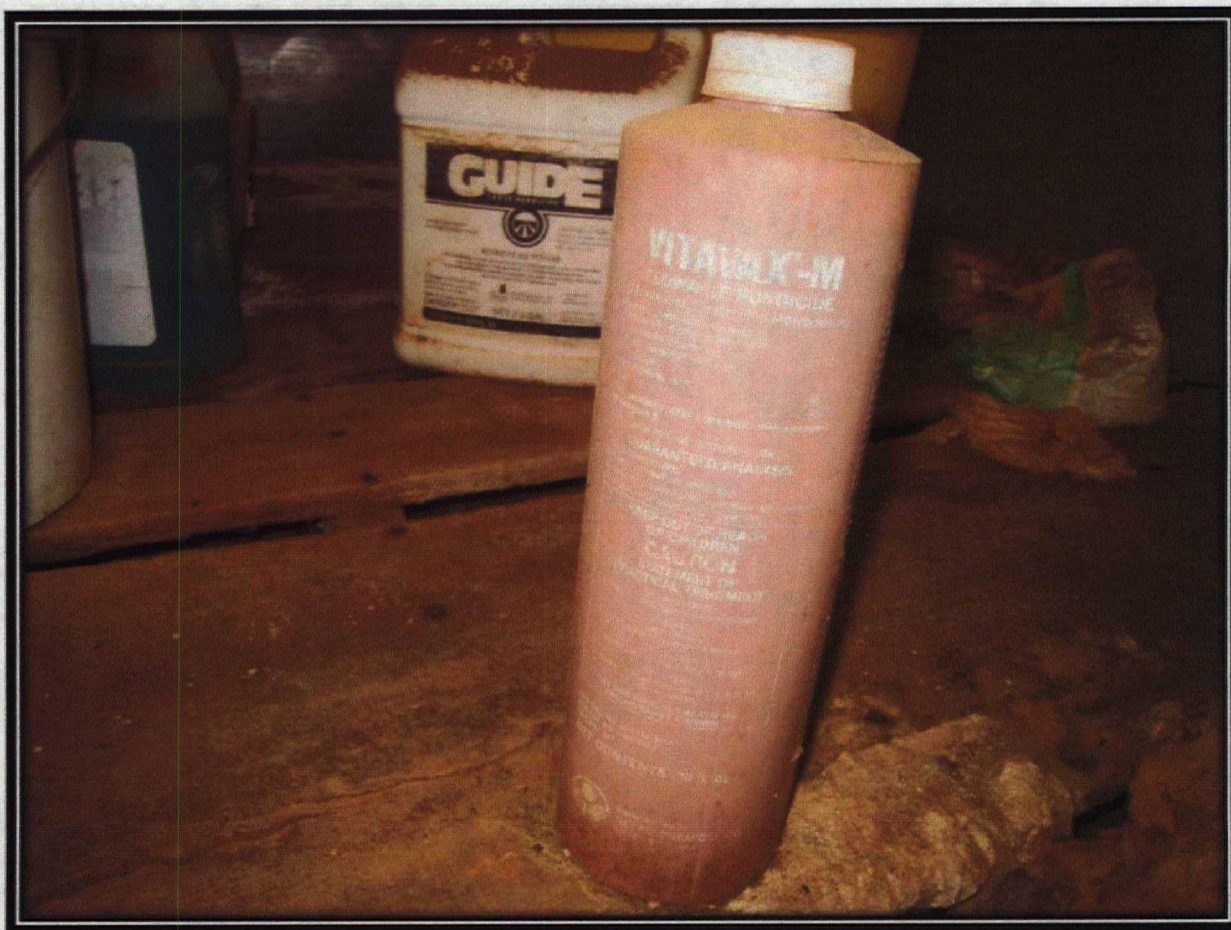
**OFFICIAL PHOTOGRAPH NO. 4**  
**U.S. ENVIRONMENTAL PROTECTION AGENCY**

**Subject:** Vitavax-M™ flowable fungicide container located inside Building 1.

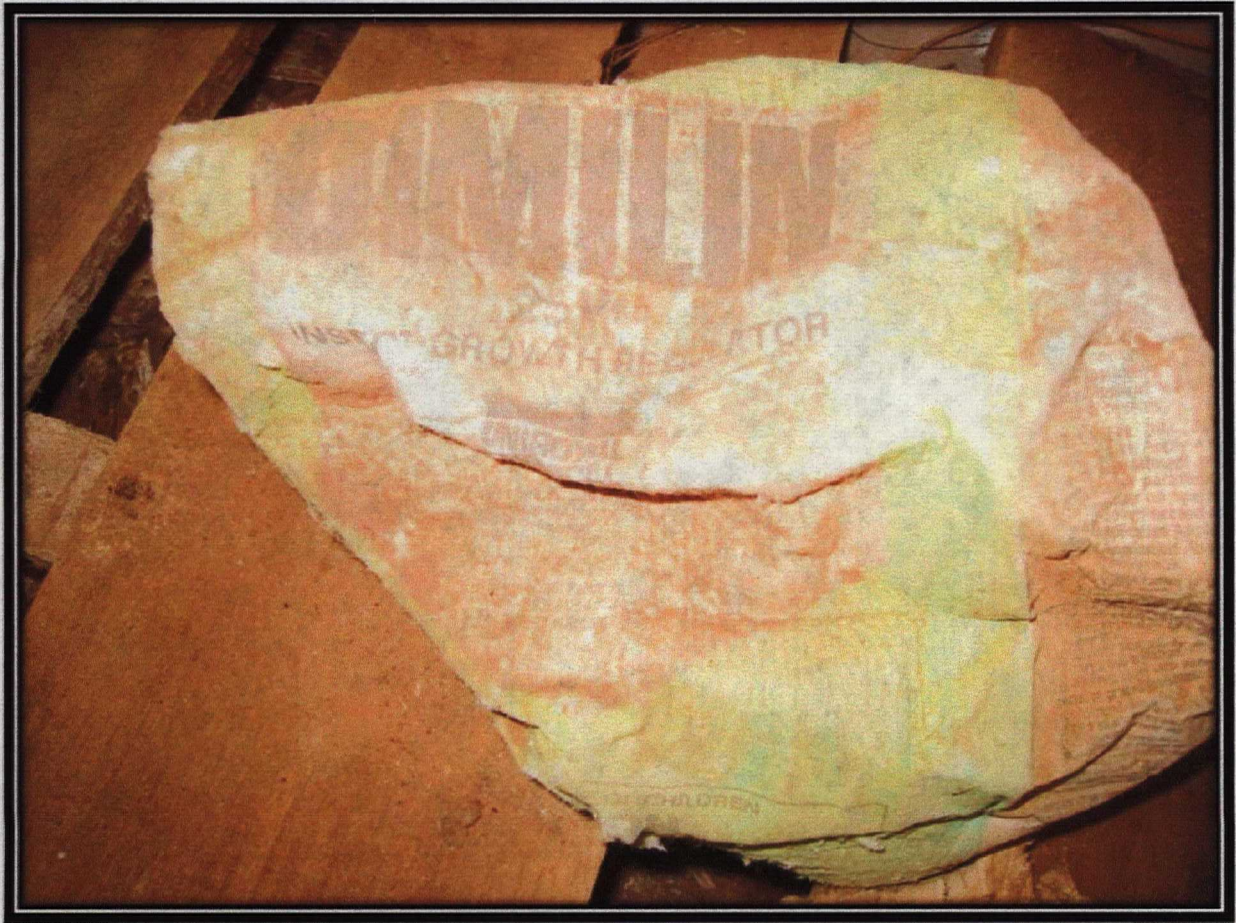
**OFFICIAL PHOTOGRAPH NO. 5**  
**U.S. ENVIRONMENTAL PROTECTION AGENCY**

**Subject:** Dimilin 25W™ insect growth regulator container located inside Building 1.

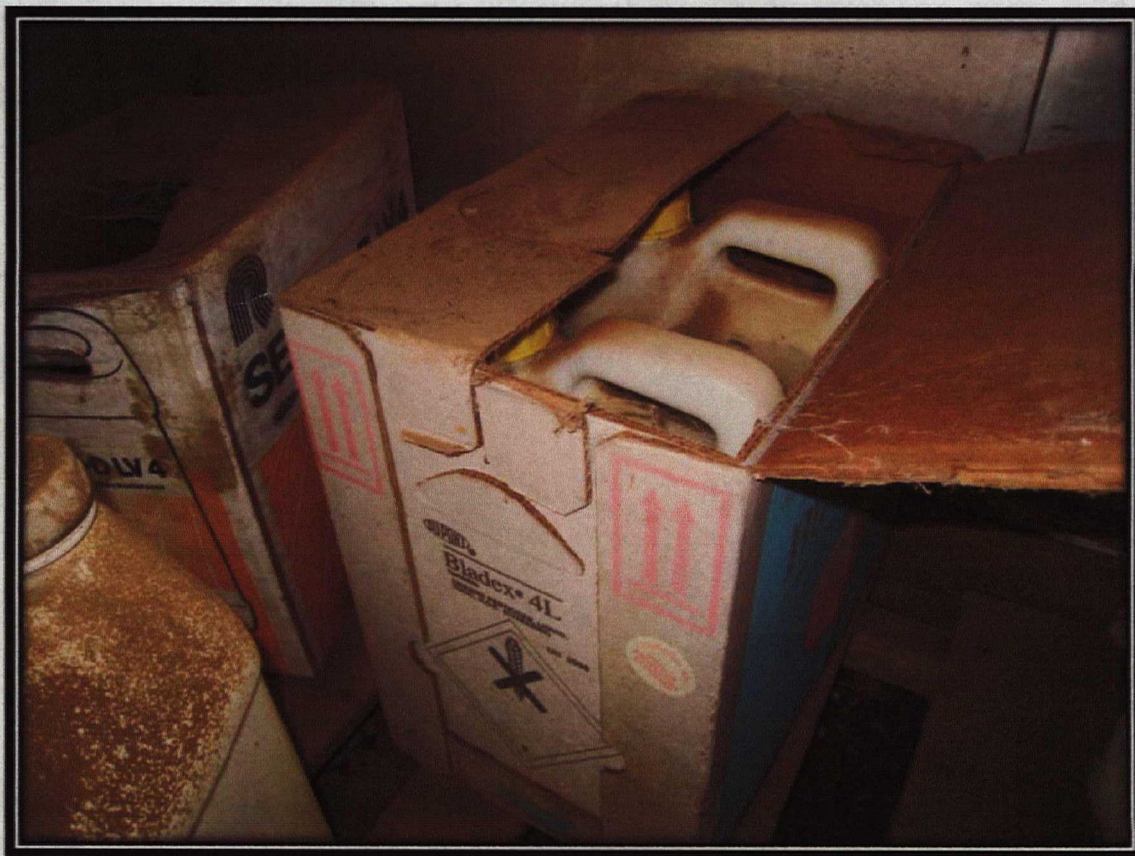
**OFFICIAL PHOTOGRAPH NO. 8  
U.S. ENVIRONMENTAL PROTECTION AGENCY**

<b>TDD Number:</b>	TTEMI-05-001-0196	<b>Location:</b>	Wingate Farms Pesticide Site
<b>Orientation:</b>	NA	<b>Date:</b>	May 31, 2013
<b>Photographer:</b>	Brian Croft, Tetra Tech	<b>Witness:</b>	Chris Jones, Tetra Tech
<b>Subject:</b>	Guthion 2L™ emulsifiable insecticide container located inside Building 1.

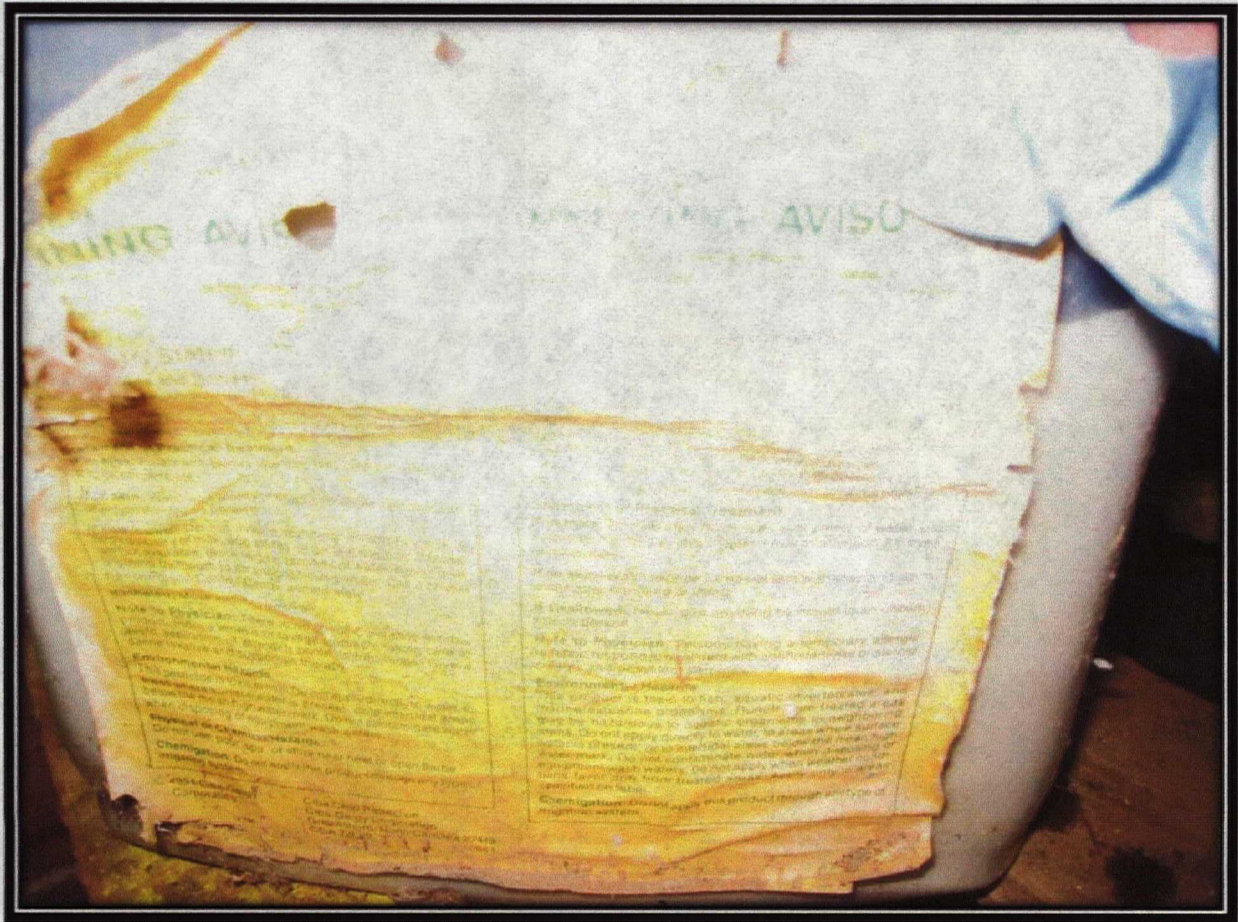
**OFFICIAL PHOTOGRAPH NO. 18  
U.S. ENVIRONMENTAL PROTECTION AGENCY**

<b>TDD Number:</b>	TTEMI-05-001-0196	<b>Location:</b>	Wingate Farms Pesticide Site
<b>Orientation:</b>	NA	<b>Date:</b>	May 31, 2013
<b>Photographer:</b>	Brian Croft, Tetra Tech	<b>Witness:</b>	Chris Jones, Tetra Tech
<b>Subject:</b>	Prowl 3.3 EC™ herbicide container located inside Building 1.

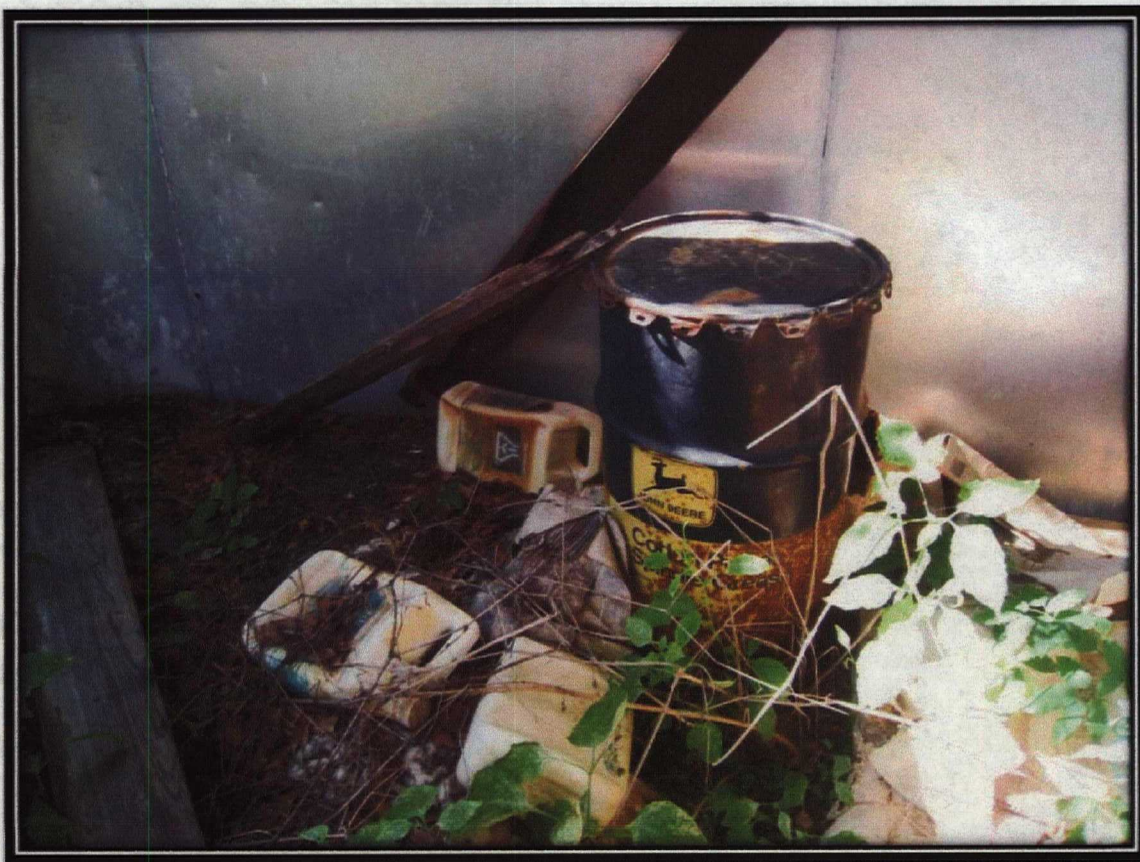
**OFFICIAL PHOTOGRAPH NO. 19  
U.S. ENVIRONMENTAL PROTECTION AGENCY**

<b>TDD Number:</b>	TTEMI-05-001-0196	<b>Location:</b>	Wingate Farms Pesticide Site
<b>Orientation:</b>	NA	<b>Date:</b>	May 31, 2013
<b>Photographer:</b>	Brian Croft, Tetra Tech	<b>Witness:</b>	Chris Jones, Tetra Tech
<b>Subject:</b>	Bravo 720™ container located inside Building 1.

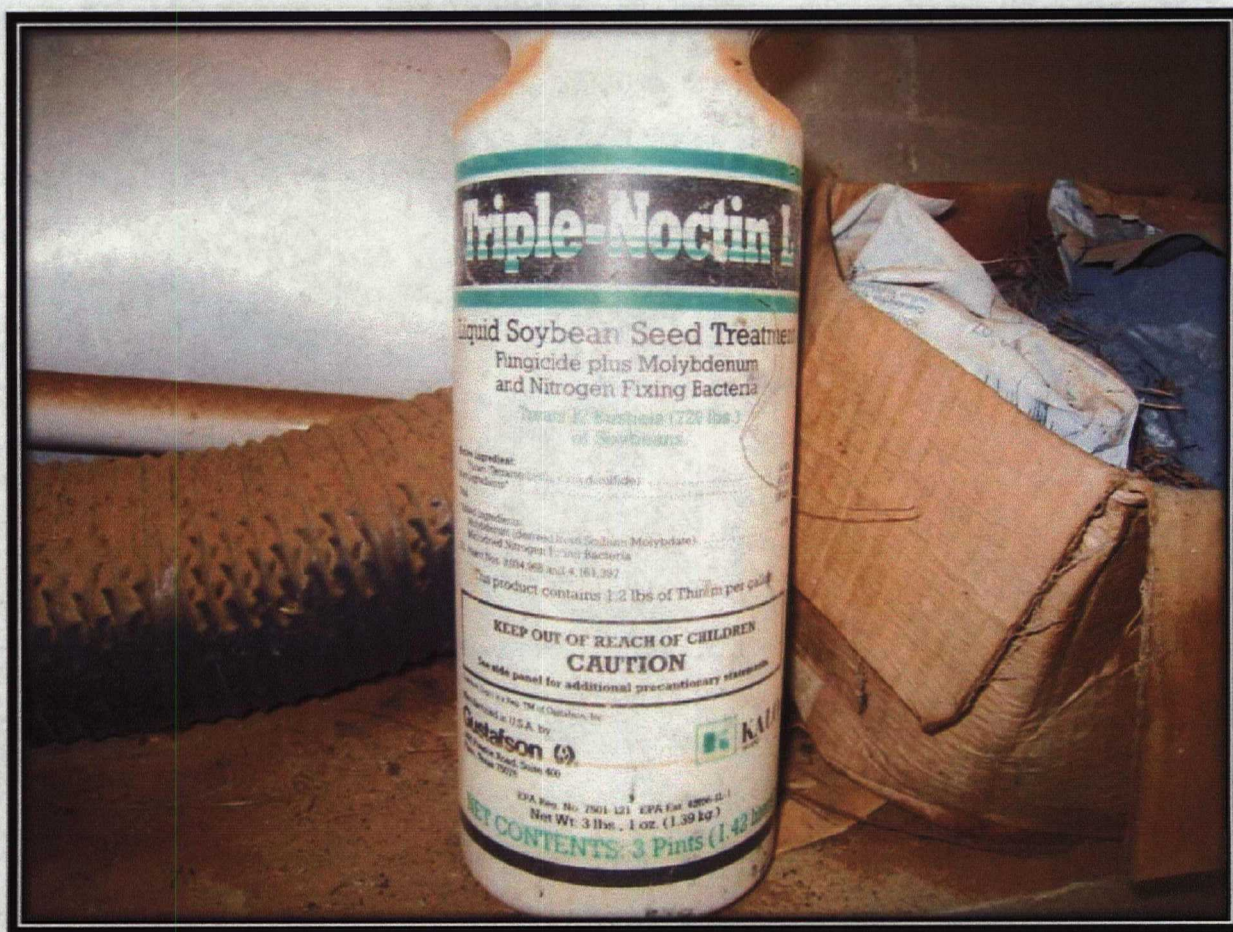
**Subject:** Malathion 5 EC™ insecticide container located inside Building 1.

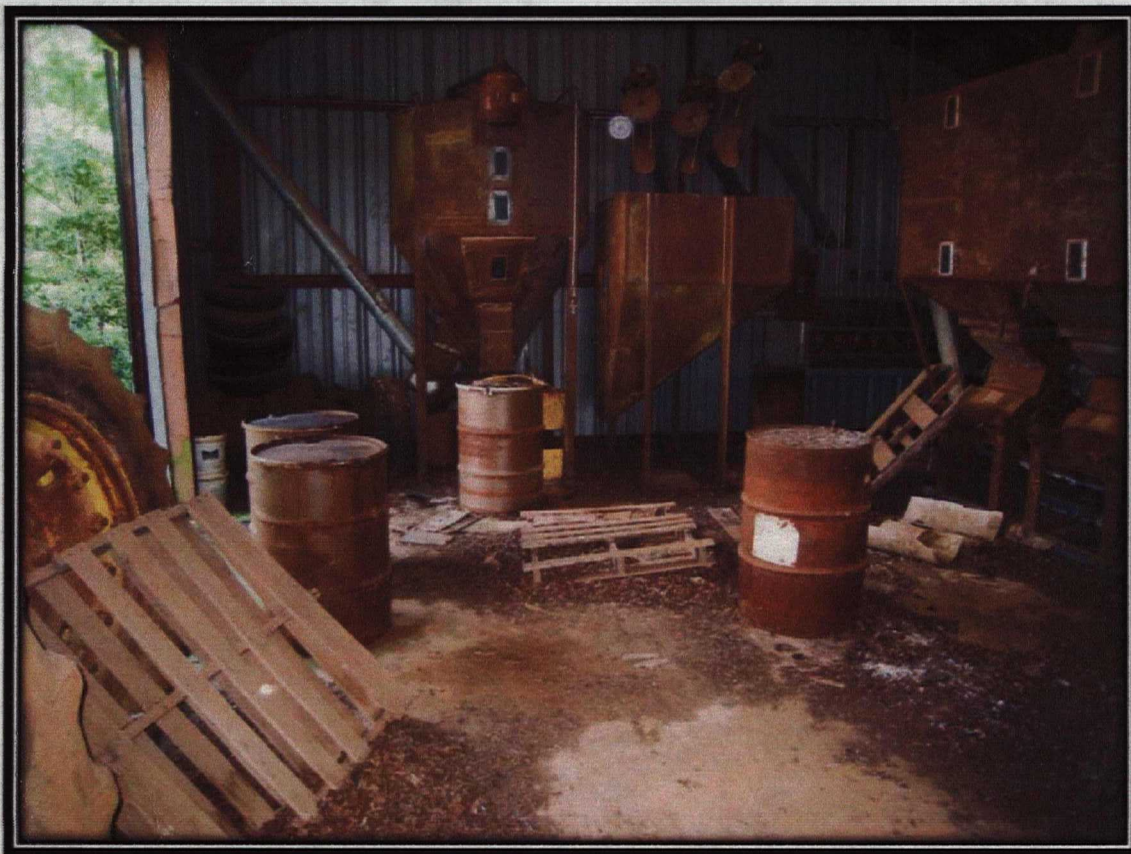
**OFFICIAL PHOTOGRAPH NO. 23**  
**U.S. ENVIRONMENTAL PROTECTION AGENCY**

**Subject:** Various drums and farm equipment located on concrete flooring in the eastern portion of Building 2.

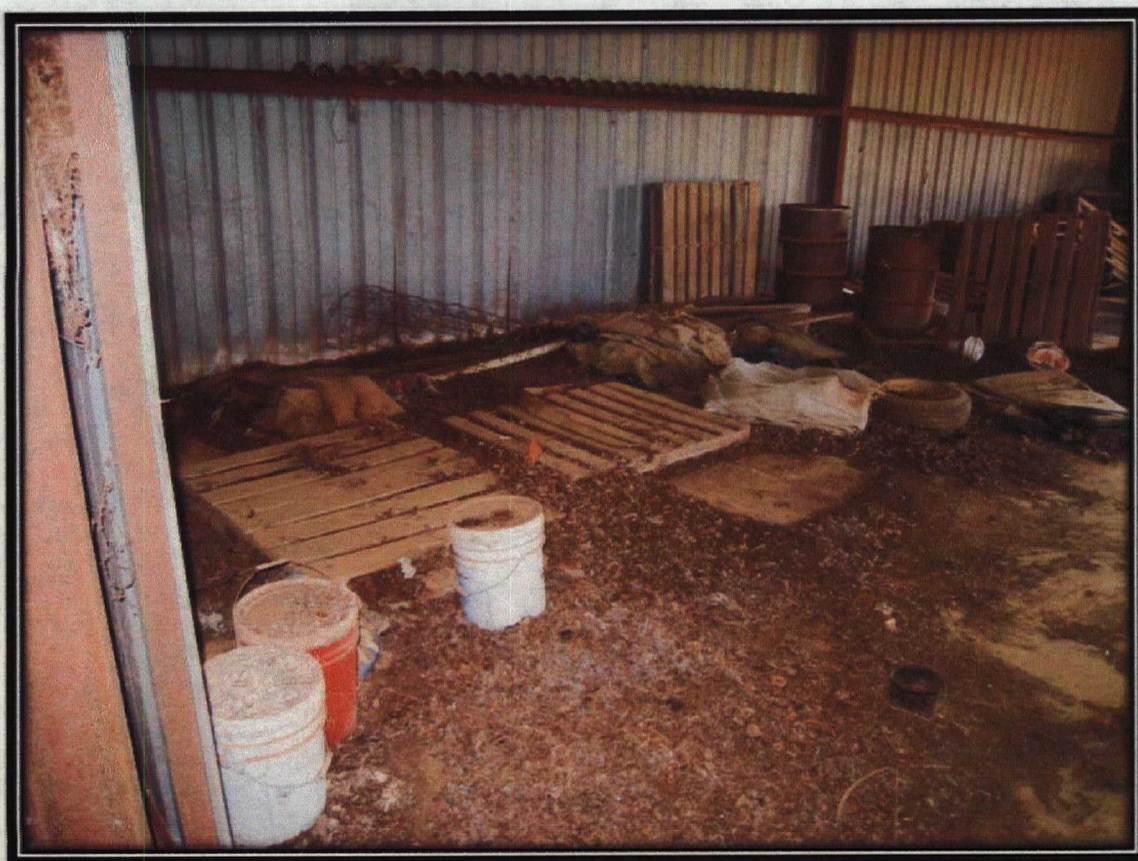
**OFFICIAL PHOTOGRAPH NO. 24**  
**U.S. ENVIRONMENTAL PROTECTION AGENCY**

<b>TDD Number:</b>	TTEMI-05-001-0196	<b>Location:</b>	Wingate Farms Pesticide Site
<b>Orientation:</b>	Southwest	<b>Date:</b>	May 31, 2013
<b>Photographer:</b>	Brian Croft, Tetra Tech	<b>Witness:</b>	Chris Jones, Tetra Tech
<b>Subject:</b>	Various drums, containers, and debris located in the central portion of Building 2.

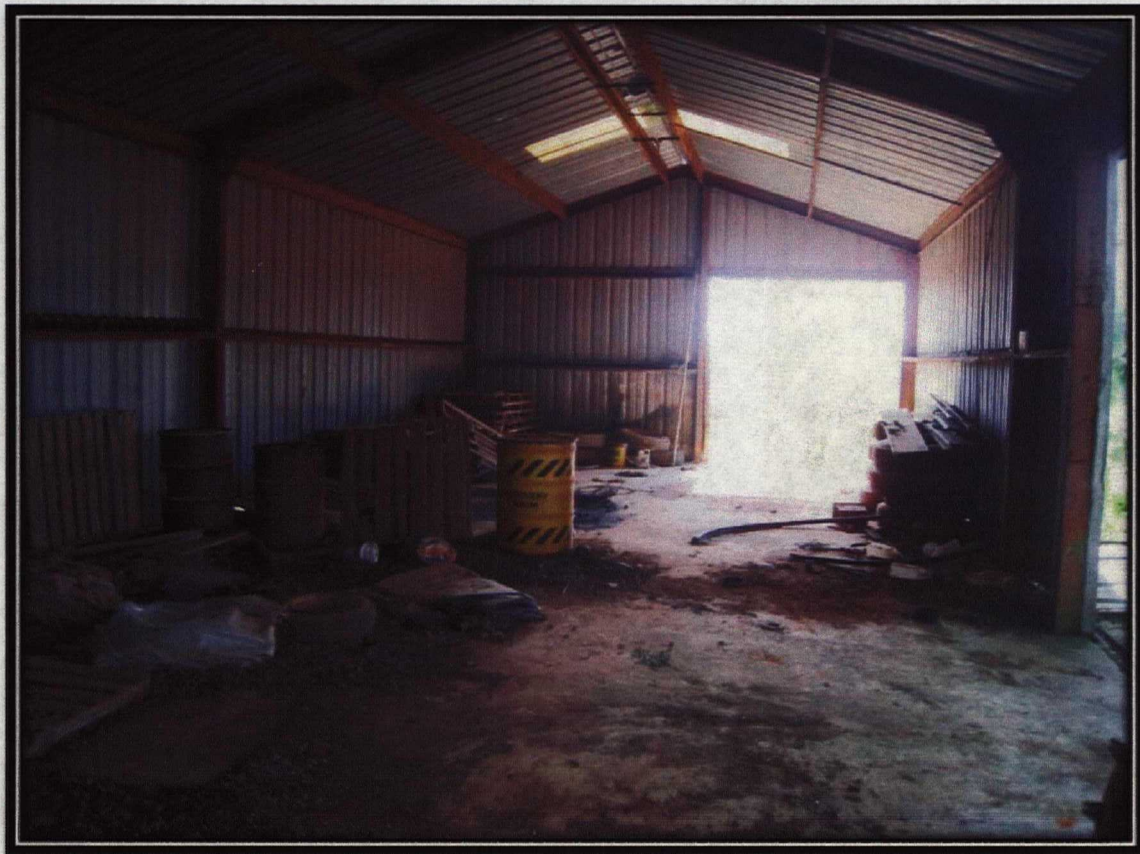
**OFFICIAL PHOTOGRAPH NO. 25**  
**U.S. ENVIRONMENTAL PROTECTION AGENCY**

**Subject:** Various drums and containers located in the western portion of Building 2.

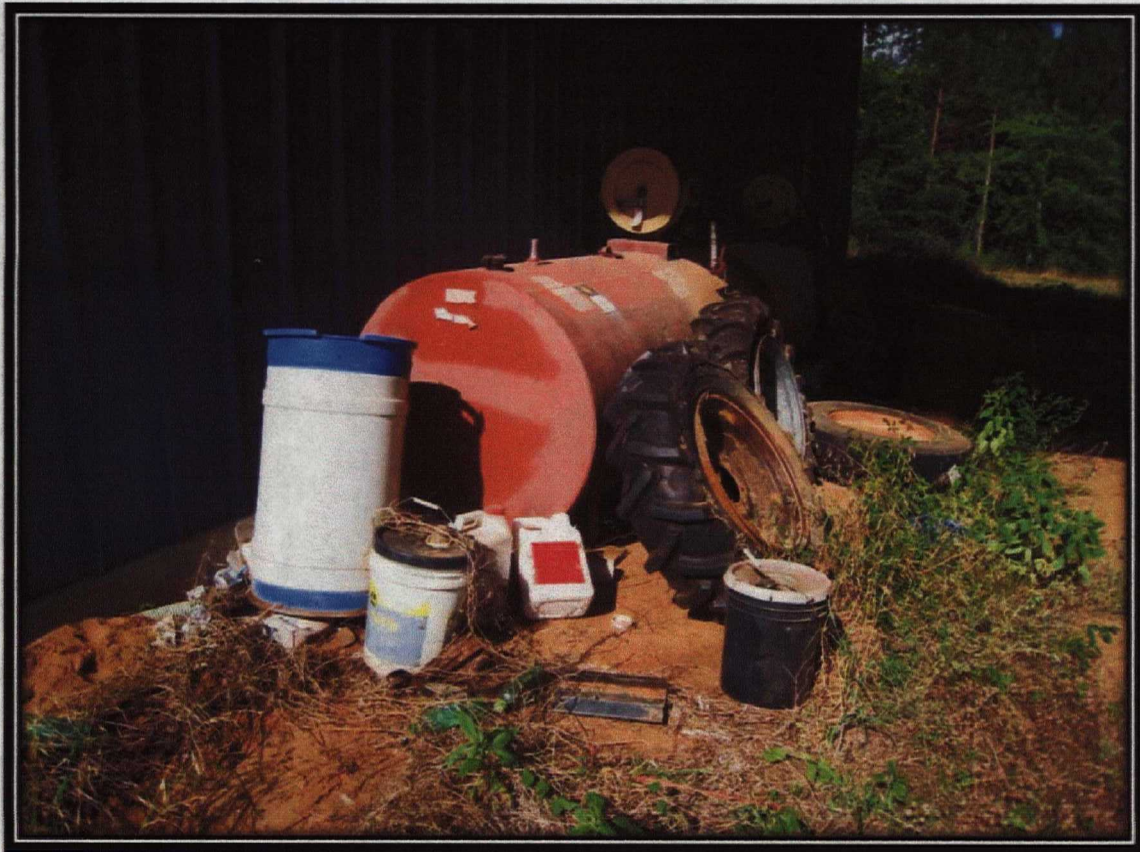
**OFFICIAL PHOTOGRAPH NO. 27**  
**U.S. ENVIRONMENTAL PROTECTION AGENCY**

**Subject:** Various containers and an aboveground storage tank (AST), located along the southern side of Building 3, were either empty or contained rainwater. A petroleum-based product was observed in the reddish-brown AST and was intended for use with farm equipment.

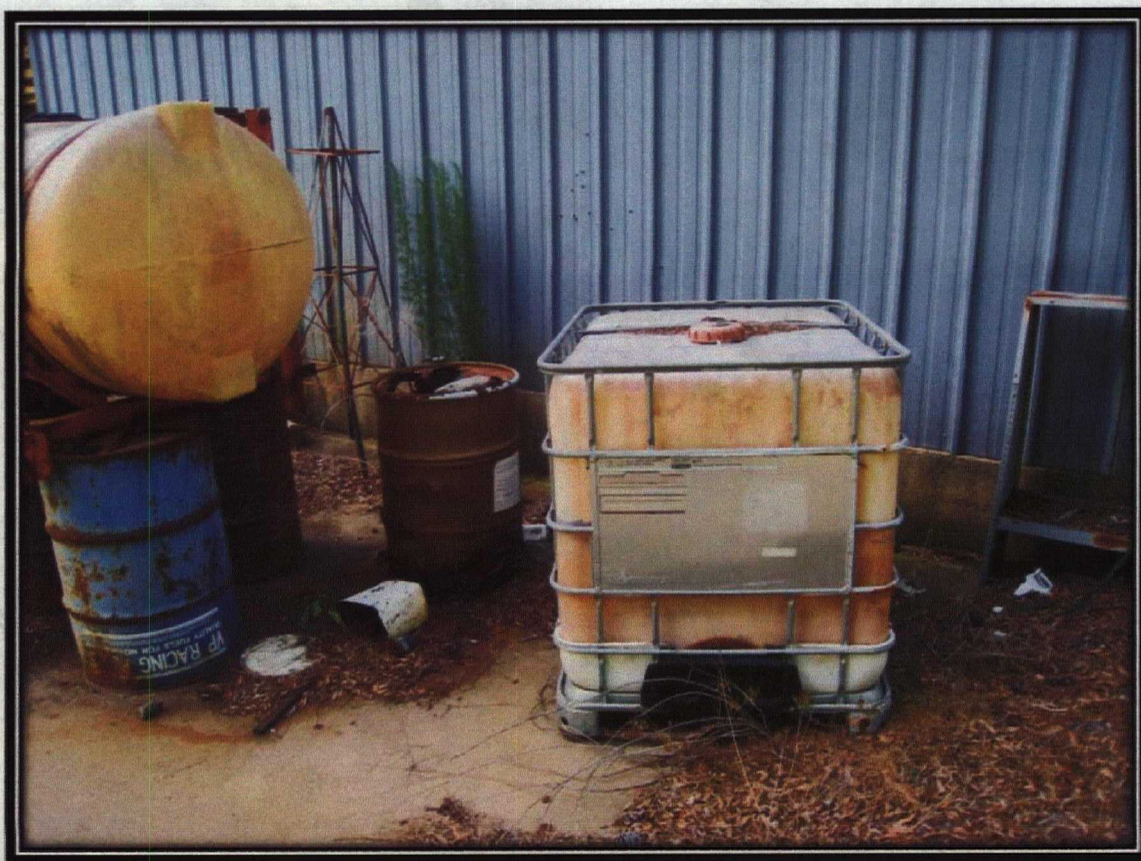
**OFFICIAL PHOTOGRAPH NO. 28**  
**U.S. ENVIRONMENTAL PROTECTION AGENCY**

**Subject:** Various containers, located along the eastern side of Building 3, were determined to be empty or to contain rainwater based on appearance and pH testing.

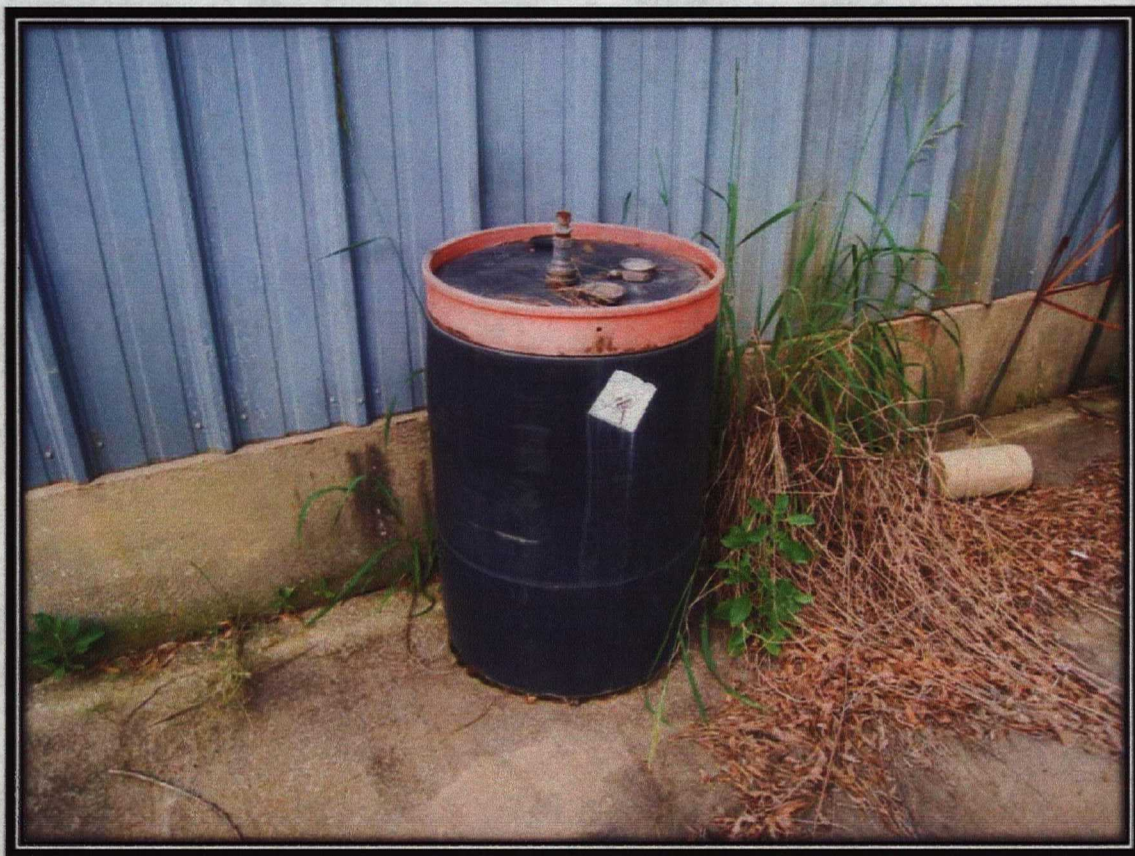
**OFFICIAL PHOTOGRAPH NO. 29**  
**U.S. ENVIRONMENTAL PROTECTION AGENCY**

**Subject:** Drum located, along the eastern side of Building 3, was determined to contain a neutral liquid based on hazardous categorization test results.

Two containers (C-11 and C-12) were located along on the eastern exterior of Building 3. C-11 contained a clear water-like liquid and C-12 was observed with two layers, a brown/light brown liquid on top of a brown/light brown sludge. The hazard categorization field screening test results for these containers indicated a neutral liquid.

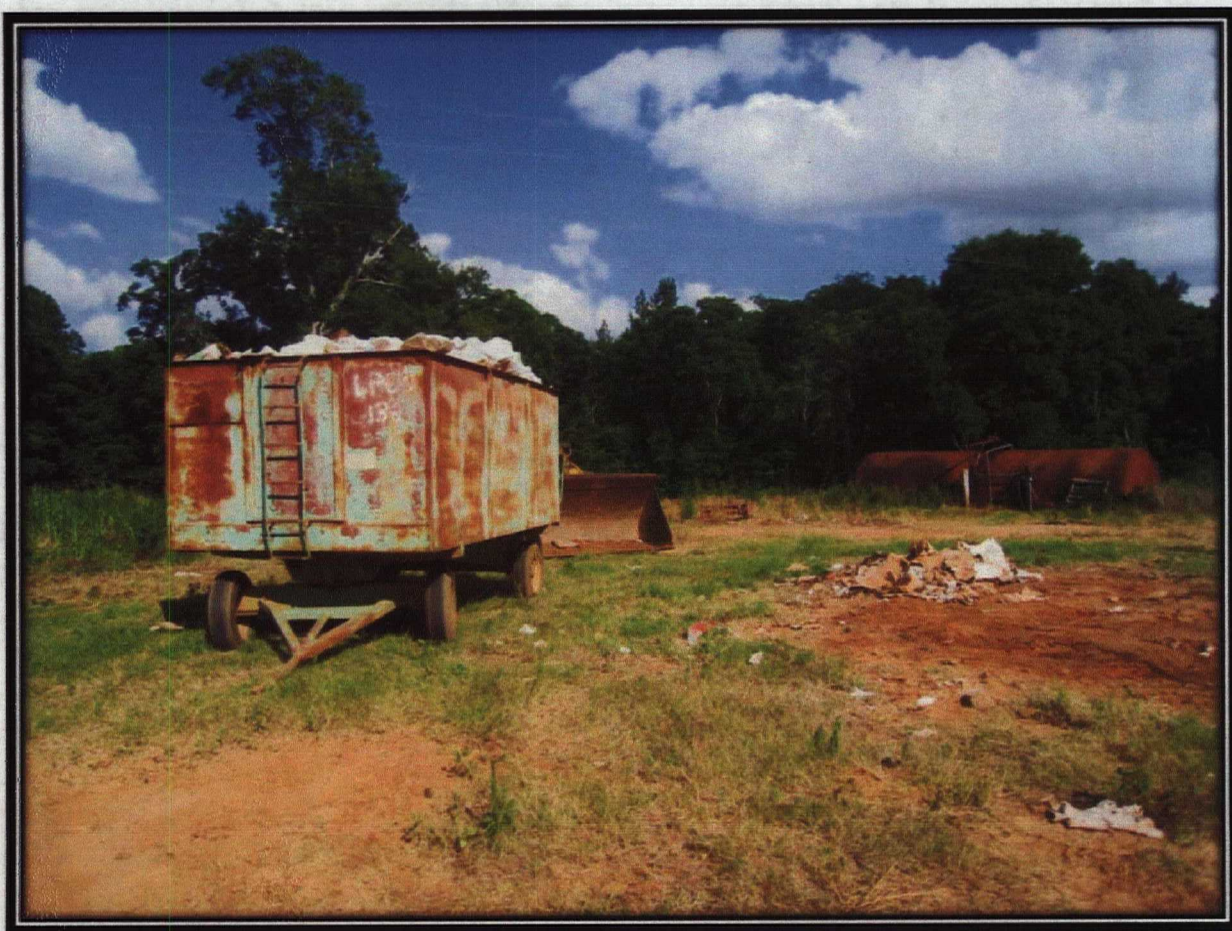
**OFFICIAL PHOTOGRAPH NO. 30**  
**U.S. ENVIRONMENTAL PROTECTION AGENCY**

**Subject:** Peanut cart containing miscellaneous discarded pesticide and herbicide containers and a large above ground storage tank (AST) located in background. The AST was no longer in use and reportedly empty.

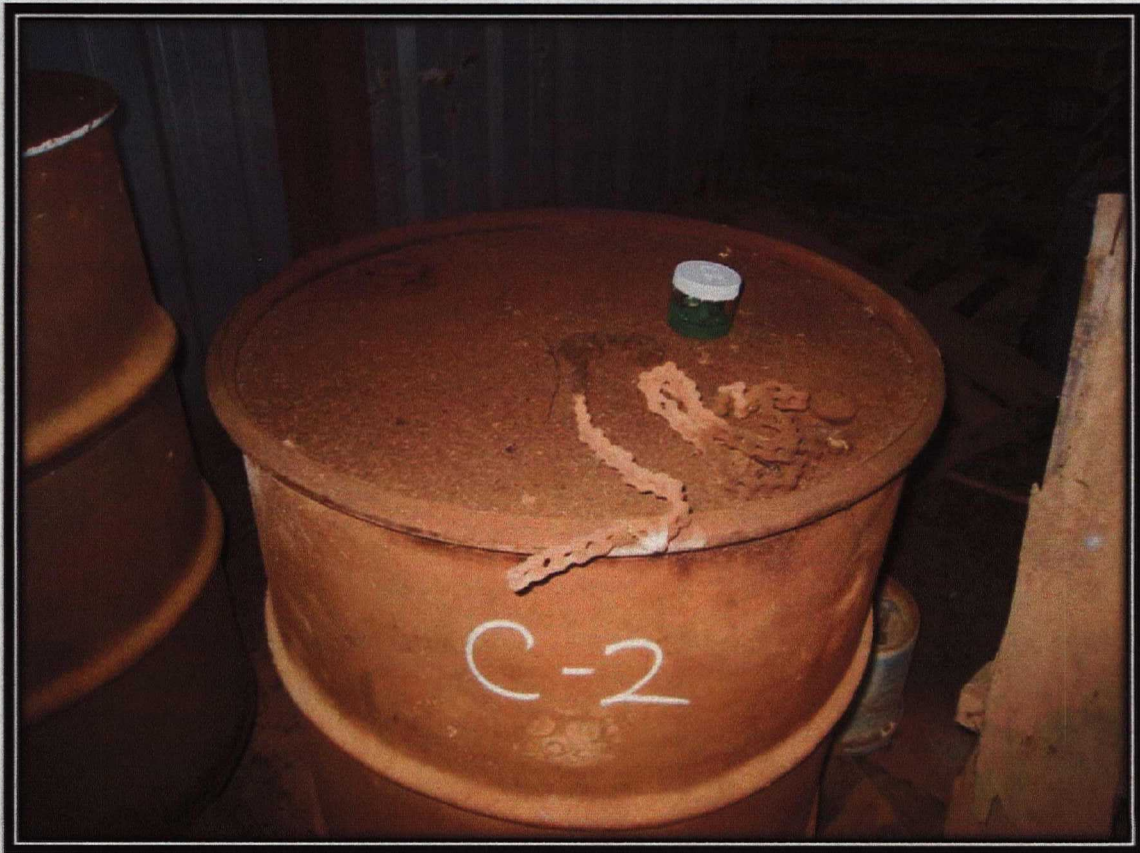
**OFFICIAL PHOTOGRAPH NO. 31**  
**U.S. ENVIRONMENTAL PROTECTION AGENCY**

<b>TDD Number:</b>	TTEMI-05-001-0196	<b>Location:</b>	Wingate Farms Pesticide Site
<b>Orientation:</b>	NA	<b>Date:</b>	June 1, 2013
<b>Photographer:</b>	Brian Croft, Tetra Tech	<b>Witness:</b>	Chris Jones, Tetra Tech
<b>Subject:</b>	Sample collected from a drum in Building 2 that was representative of John Deere Cotton Picker Spindle Grease™ found in other containers at the site.

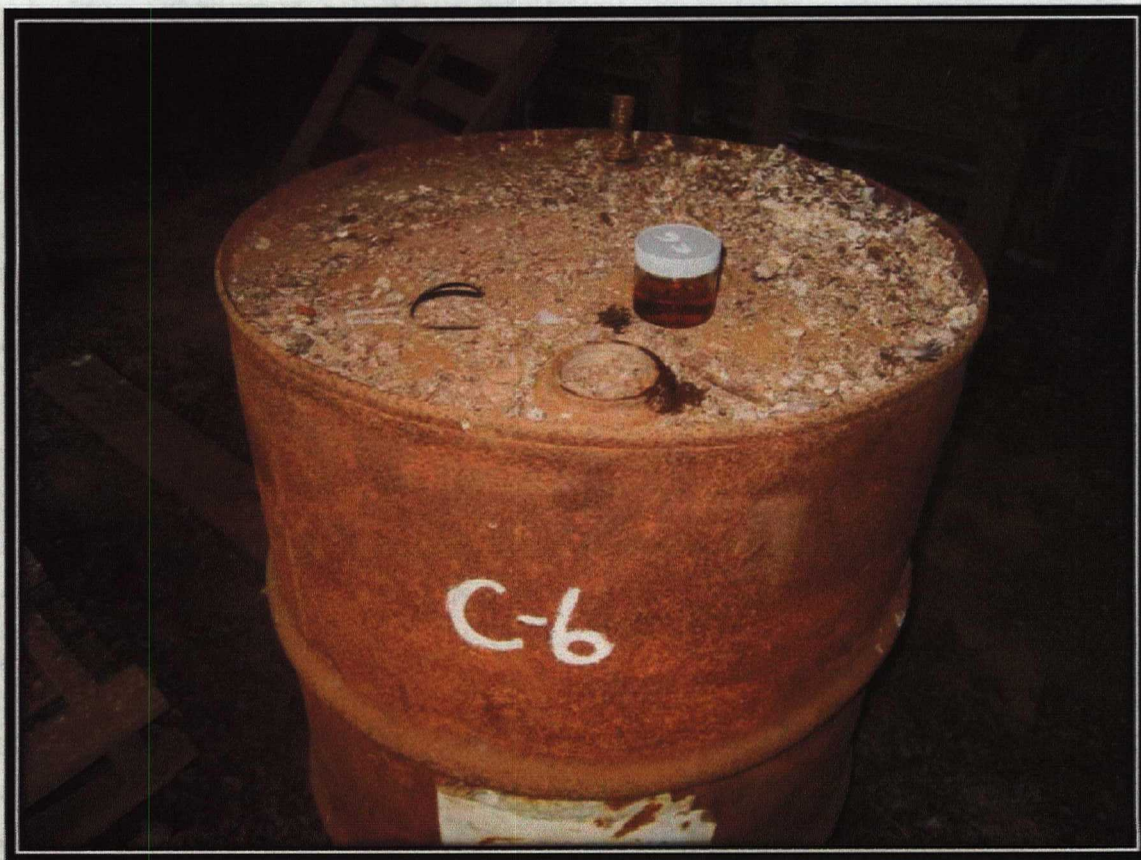
**OFFICIAL PHOTOGRAPH NO. 32**  
**U.S. ENVIRONMENTAL PROTECTION AGENCY**

<b>TDD Number:</b>	TTEMI-05-001-0196	<b>Location:</b>	Wingate Farms Pesticide Site
<b>Orientation:</b>	NA	<b>Date:</b>	June 1, 2013
<b>Photographer:</b>	Brian Croft, Tetra Tech	<b>Witness:</b>	Chris Jones, Tetra Tech
<b>Subject:</b>	Sample collected from a drum in Building 2; hazard categorization field screening test results indicated that the material is likely a pesticide.

Tetra Tech START was tasked to conduct hazard categorization field screening tests on the contents of the drums located in Building 2 and behind Building 3 (see Enclosure 4). Most of the drums in Building 2 were observed to contain a green/light green gel or grease and estimated to contain only 5 percent of their total volume. Available label information for these drums (C-1 through C-3 and C-7 through C-9) indicated that they contained cotton picker spindle grease. The hazard categorization field screening test results for this material appeared to indicate an organic gel or grease, consistent with the label information. The contents of one drum (C-6) in Building 2 appeared to resemble brown oil and turned a milky color when added to water during hazard categorization field screening testing. This color change indicates that the substance is likely a pesticide.
